Manhole Inspection Summary

Manhole # S09WW1015MH

Insp Date: **7/29/06 8:14 AM**

Location Address: **2700 W NORTHERN PKWY**

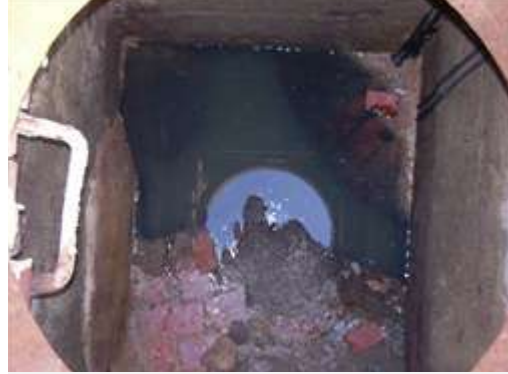
Top View

☐ Parged ☒ **Debris** (not Condition related)

Count: **1** Missing: **0** ☒ **Corroded**

☒ **Evidence Of Surcharge** Depth: **1** (ft.) ☒ **Active Surcharge Present**

Corroded steps. Evidence of surcharge - Bench debris.

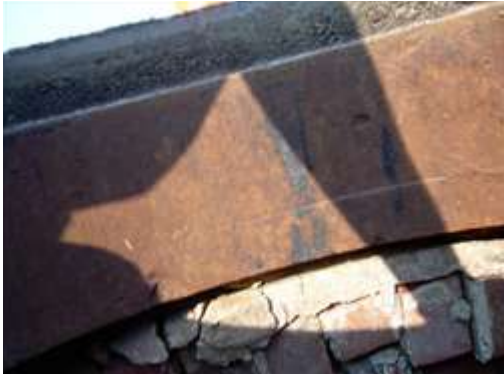
Defect

Condition: ☐ Sound ☐ Cracked ☐ Root Intrusion ☒ **Loose Brick** ☒ **Deteriorated**

Infiltration: ☐ None ☒ **Joint** ☐ Cracks ☐ Mortar ☐ Roots ☐ Wall

Frame leaks. Corbel deterioration, loose brick and infiltration.
